## CONFIDENTIAL INSPECTION REPORT

Sample Report, , CA

8/16/2012 9:00 am to 3:30 pm

## SUMMARY REPORT

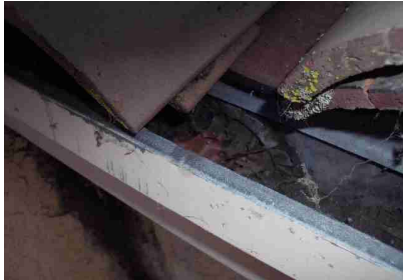
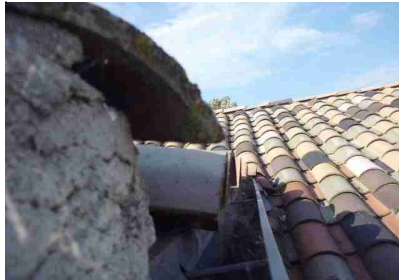
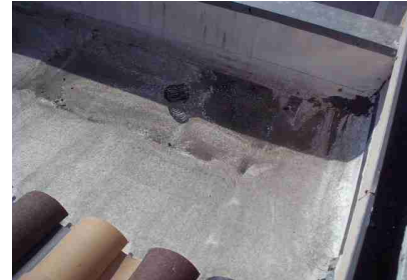
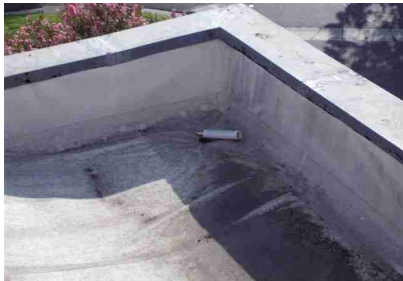
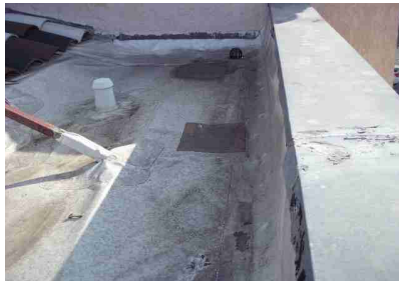
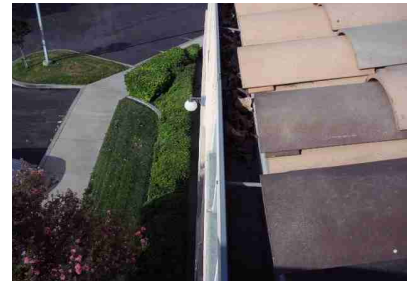
There are leaves/excess debris in the rain gutters, and roof scuppers. These are so clogged that they appear to be spilling over at various locations. Recommend evaluation by a Licensed C39 Roofing Contractor who is familiar with commercial roof drainage.

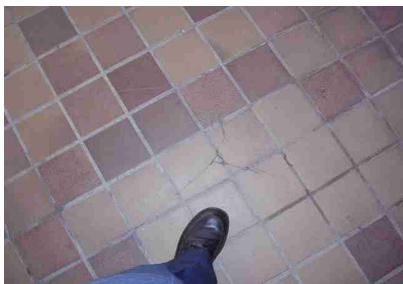
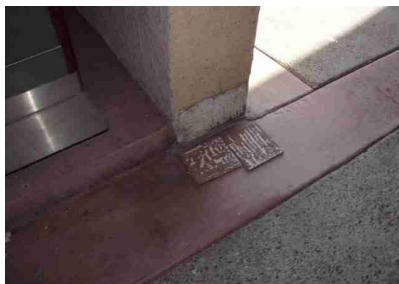
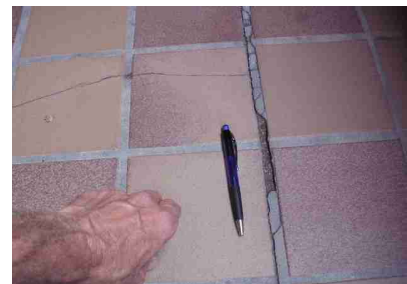
There are a number of cracked tiles, and some missing grout on the tile walkways, and a couple of detached tiles near the front entry.. Recommend evaluation by a licensed C54 Tile Contractor

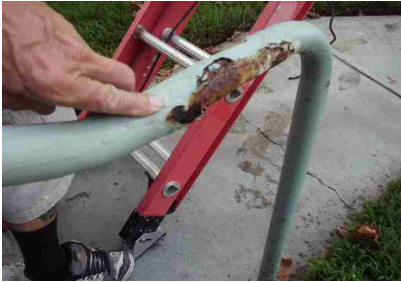
The west side exterior step rails are rusty. Maintenance is needed

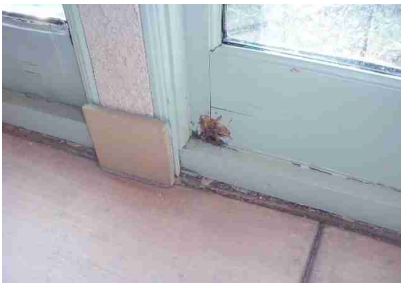
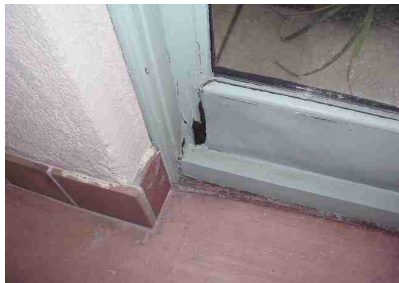
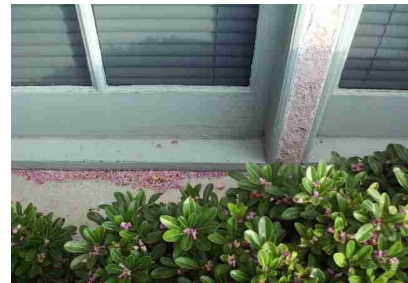
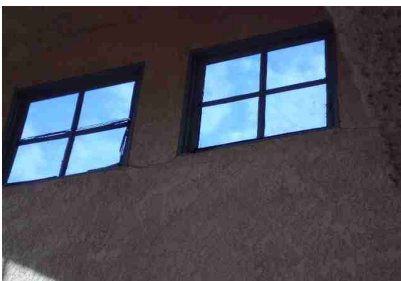
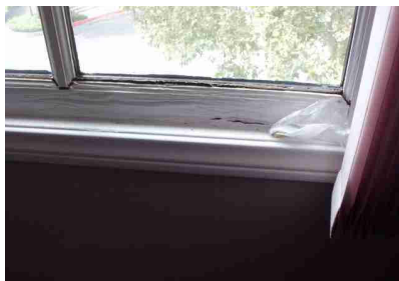
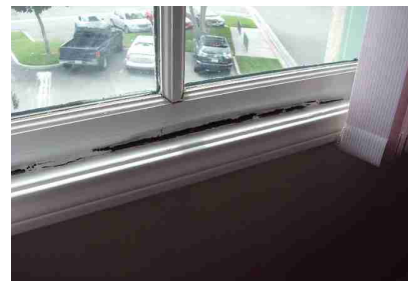
Many of the exterior window frames are damaged, and some of the interior frames are damaged on the west, and south sides of the building, and evidence that water is getting into the interior areas. Recommend evaluation by a Licensed C17 Commercial Window Contractor, and many windows will likely need to be replaced.

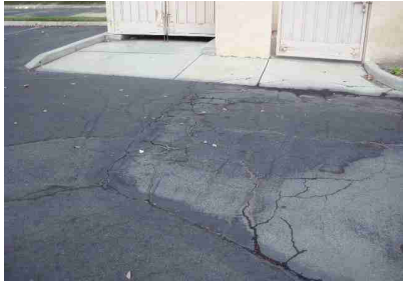
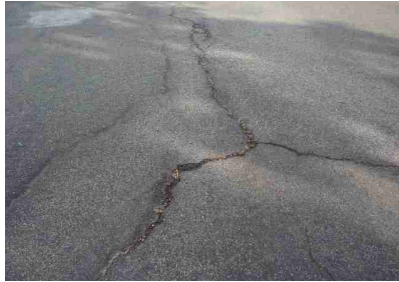
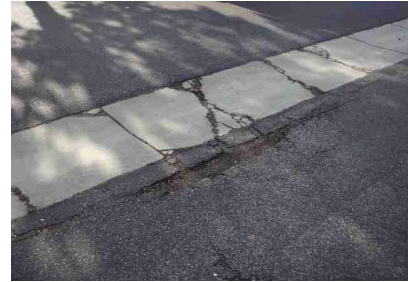
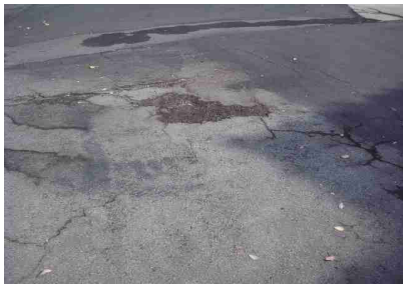
There are cracks, and surface wear at various locations on the parking lot. Recommend evaluation by a Licensed C12 Commercial Paving Contractor.

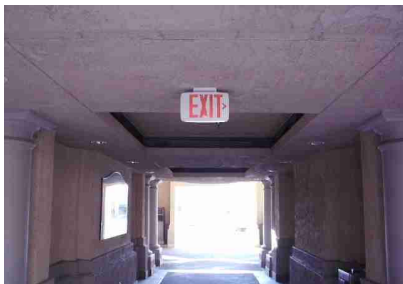
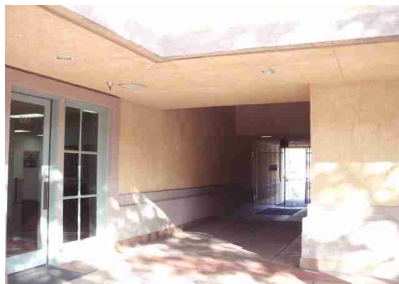
The front courtyard exit sign points away from the exit, and there is no rear sign that is viewable from within the courtyard. Proper exit signage is recommended.

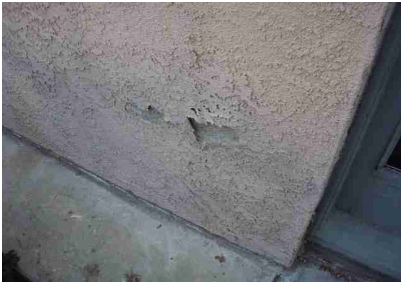
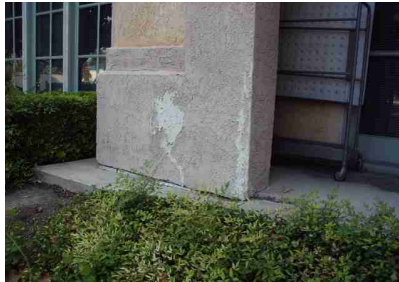
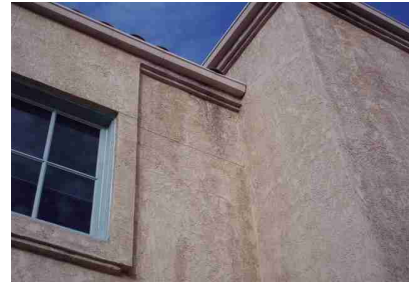
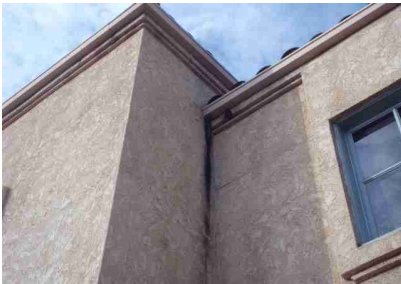
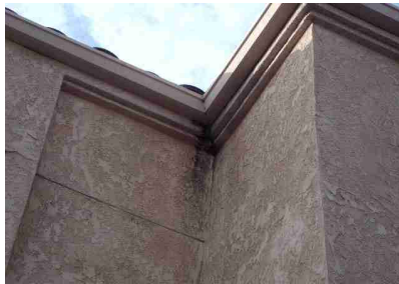
There is some spalling on the north west corner, and repairs on the west wall. There are stains below many of the gutters. Maintenance is needed

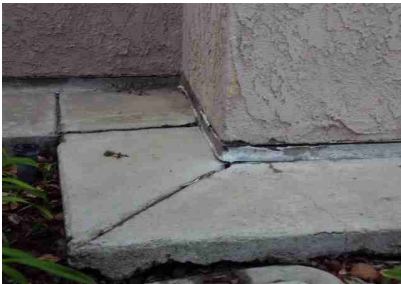
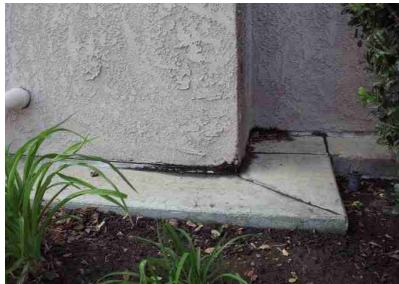
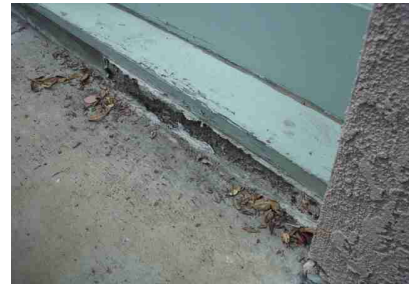
This is mortar in the space between the weep screed, and decking noted at concrete decking and/or planters. The weep-screed not only allows the walls to move independent of the foundation and prevents the plate-line cracks that are commonly seen at the base of many stucco walls but allows any moisture that penetrates the stucco to drain, as well as for ventilation. Therefore the interior and exterior plaster in this area should be monitored to ensure that no moisture damage results. Mortar fill should be removed. Recommend evaluation by a Licensed C35 Lath and Plaster Contractor

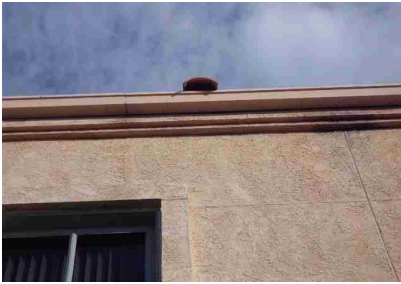
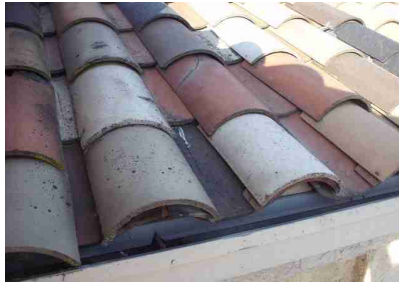
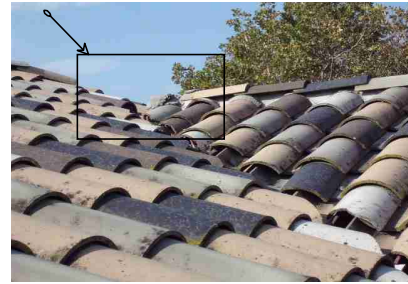
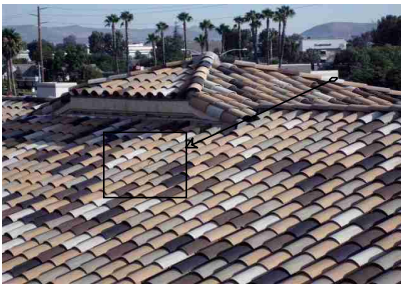
There are a few slipped tiles, detached mortar, and fractured tiles at various locations.. Recommend evaluation by Licensed C39 Roofing Contractor.

Slipped tile noted at edge on north side  
Fractured tiles noted on east panel  
Detached mortar noted at peak on east side

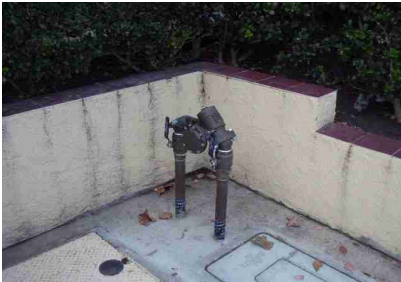
There are back flow prevention devices on site.. These devices typically require regular code mandated maintenance. You may want to inquire with seller regarding recent or future maintenance requirements.

Two near the north west corner, and one near the south west corner

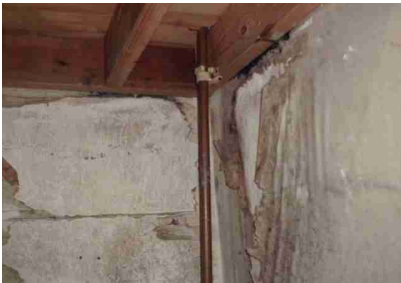
There is evidence of past leakage on the water heater base/walls. Dark blotchy staining noted may be some sort of Microbial growth, and should be properly cleaned up. See moisture concerns near end of report regarding moisture investigation, and repair.

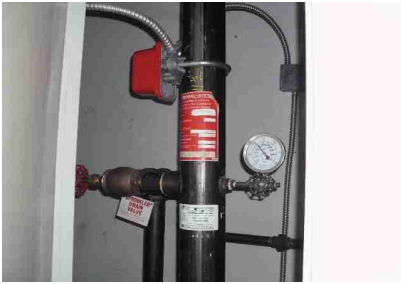
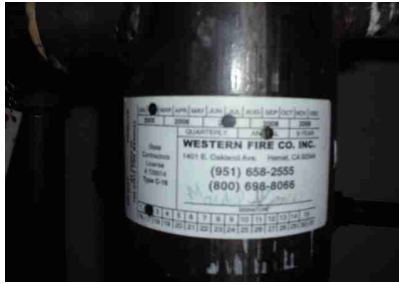
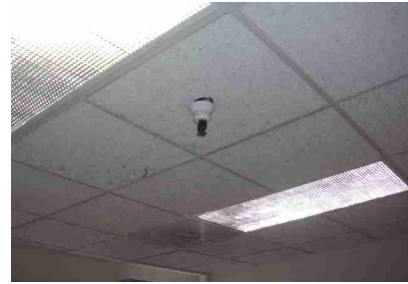
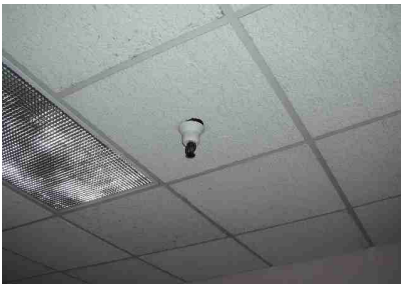
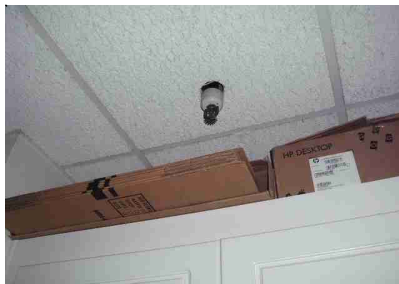
Note: Sprinkler riser is located in unit 110.. Service tag indicates system is in need of service/certification

Some of the interior office sprinkler collars are loose/detached, and should be evaluated by the Fire Sprinkler Contractor while on site.

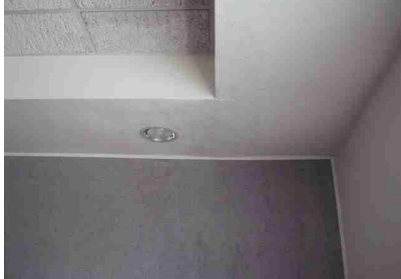
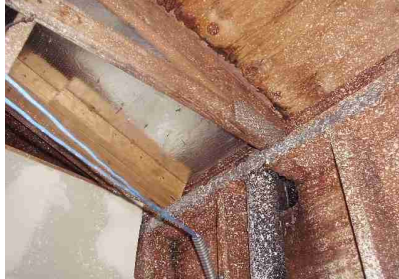
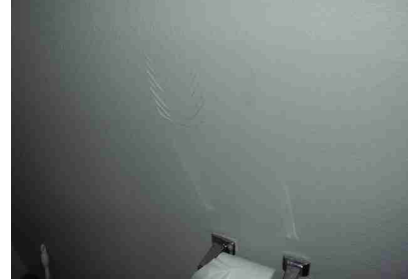
There is evidence of moisture intrusion on the ceiling in unit 200, and in the bathroom in unit 211. The ceiling/wall stains in unit 200 appear to be roof related, and may have been repaired in the recent past. You should seek out the repair paperwork, or have the roofer evaluate this condition while on site. The stains in unit 211 bathroom are from past leakage from the water heater above, that has been abandoned. See moisture concerns near end of report regarding moisture investigation, and repair.

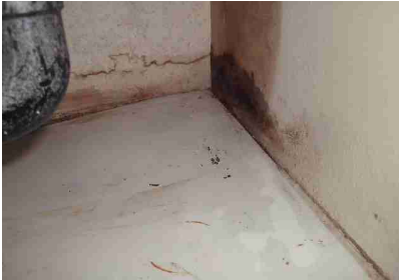
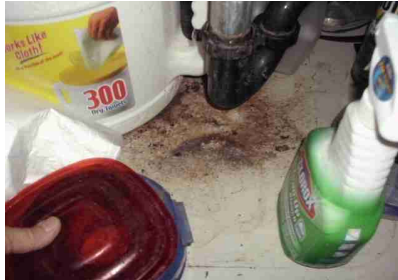
There is active leakage under the sink in unit 213, and evidence of past leakage under the sink in unit 200. Recommend evaluation by a licensed C36 Plumbing Contractor to repair leakage. Moisture stained cabinet bases should be removed to inspect for hidden damage, and replaced. See moisture concerns near end of report regarding moisture investigation, and repair.

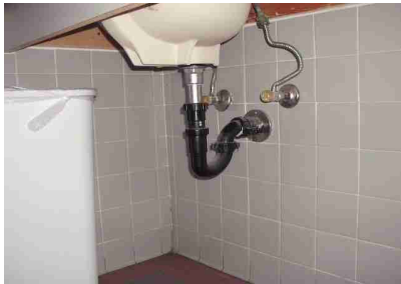
No insulation noted on piping under sinks

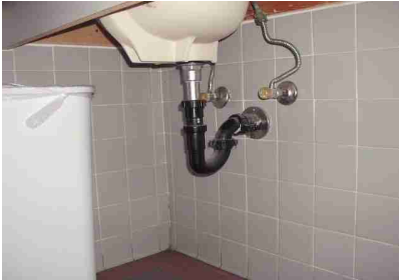
No insulation noted on piping under sinks
