American Real Estate Inspection

CONFIDENTIAL INSPECTION REPORT

Gothard Street, Huntington Beach, CA 92647

2/15/2017

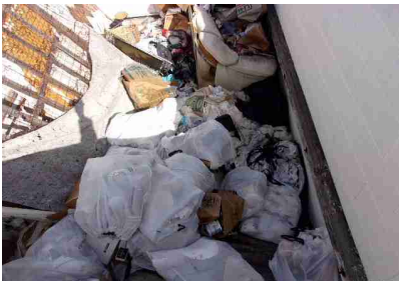
The trash enclosure area in front is full of trash. This waste will need to be properly disposed of.

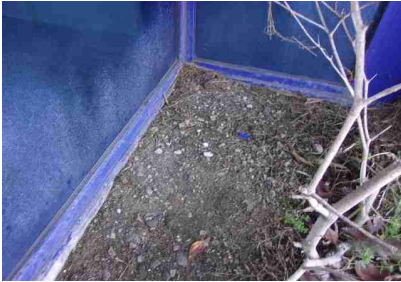
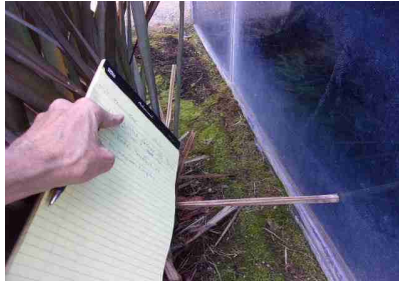
There is soil piled on the exterior window bases that should be removed, and kept clear of the windows to prevent corrosion of the sills

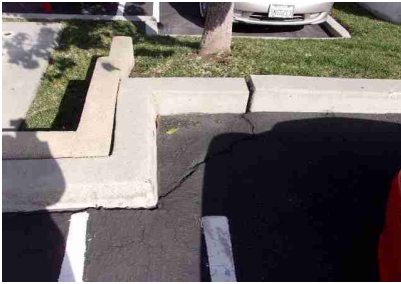
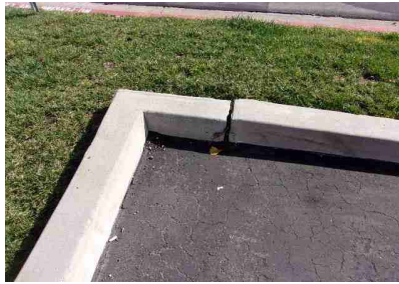
Cracked curbs - Continued

There are some cracked curbs in the parking area. Maintenance is needed

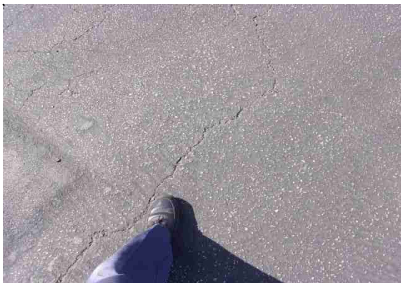
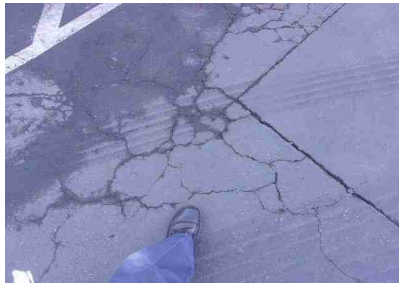
There are cracks at various locations on the parking lot. Cracks allow water to penetrate below the surface and can lead to premature failure of the asphalt if not maintained/sealed on a regular basis.. Recommend evaluation by a Licensed C12 Commercial Paving Contractor.

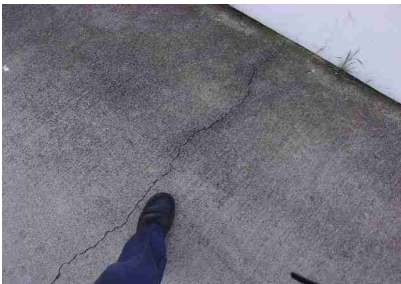
The truck bay concrete is cracked. Cracks should be sealed to prevent water from seeping below the concrete

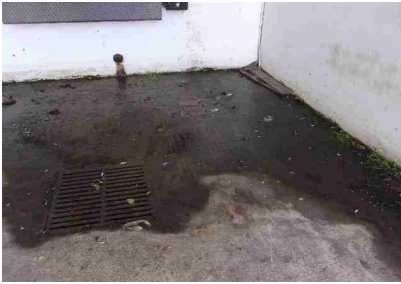
Standing water noted in truck bay - Continued

There is standing water in the truck bay, this may be from rain water that is collecting near the drain sump or slow roof runoff. In any case standing water can turn mossy which could lead to slipping, or breed insects. Recommend evaluation by a qualified drainage contractor to determine why this is happening and rectify it.

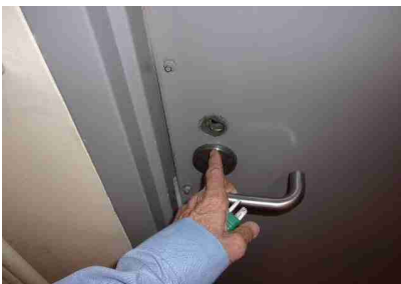
The metal utility doors are functional.

Note: Top lock missing on left side door. Maintenance is needed

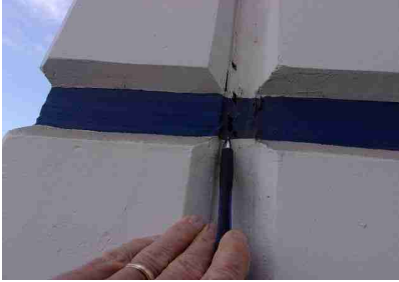
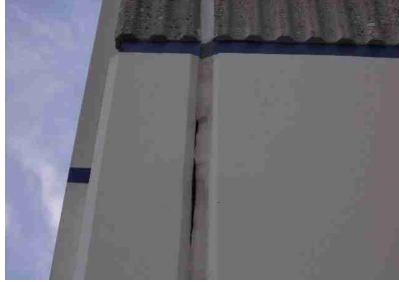
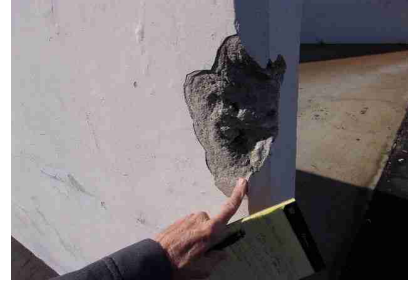
The wall panel sealant is cracked in front near the left roll up door. Sealant joints should be serviced. There is a large chip on the panel in front of the truck bay. Recommend evaluation by a qualified Contractor who is

familiar with concrete tilt up wall panel seals and repairs.

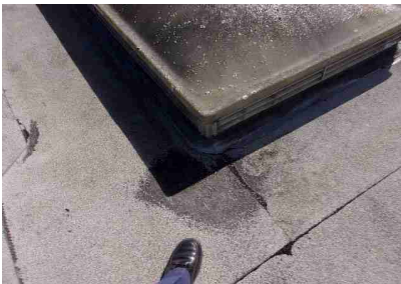
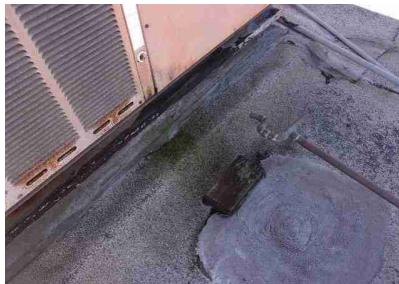
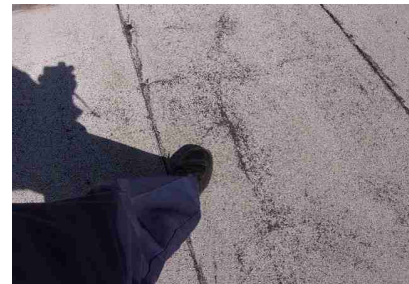
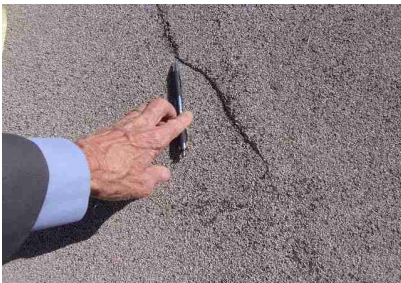
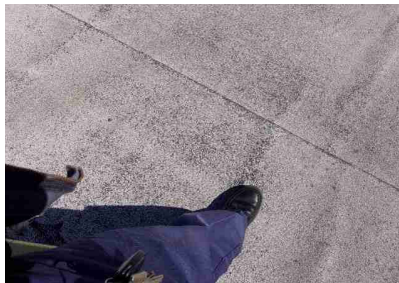
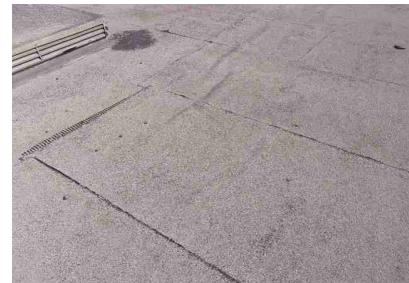
The roof is in the primary stages of decomposition, which means that the roof is in decline and there are a number of areas where the aggregate has worn off, and there are areas that are raised up forming small dams that can impede water runoff. This also indicated the material is lifting off of the base. There is evidence of current leakage in the warehouse and upper offices. Roof appears to be at or near the end of it's serviceable life span. Recommend evaluation by a Licensed C39 Roofing Contractor who is familiar with flat commercial roof covering

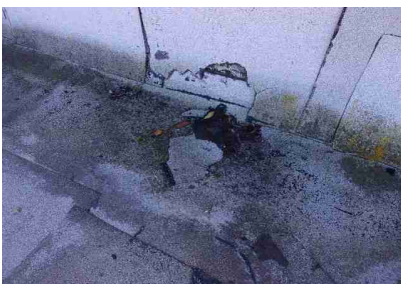
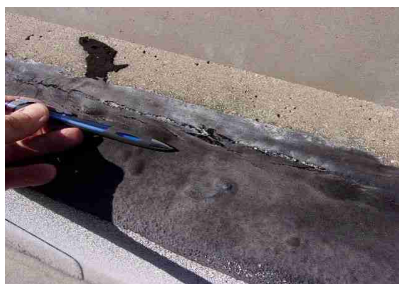
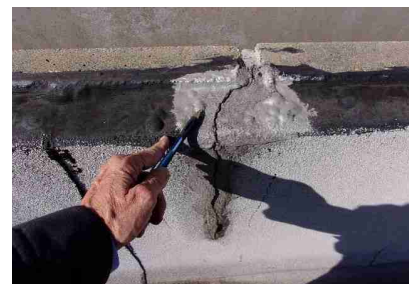
There are some split mastic seams on the parapet walls, and there is exposed black mastic at various locations that is cracked. Black mastic should be coated with a reflective coating to prevent extreme temperature e variations which can cause excessive splitting. Recommend evaluation by a licensed C39 Roofing Contractor who is familiar with this type of roof covering.

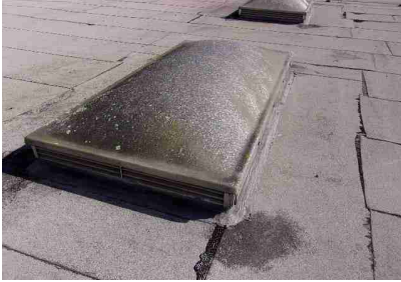
The skylights are weathered, and the fibers are exposed. Recommend evaluation by a Licensed C39 Roofing Contractor who is familiar with commercial skylights

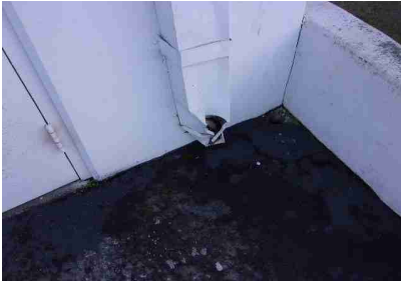
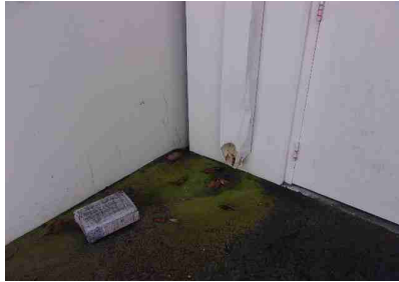
There are some damaged downspouts. Maintenance is needed

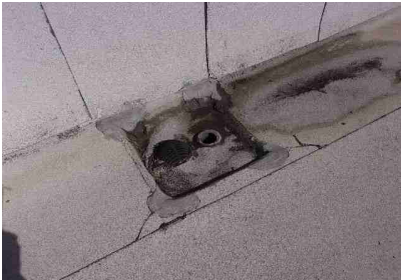
There is debris in some of the scupper drains. Maintenance is recommended.

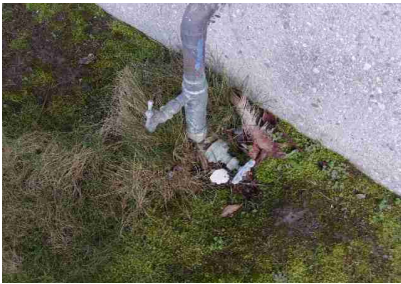
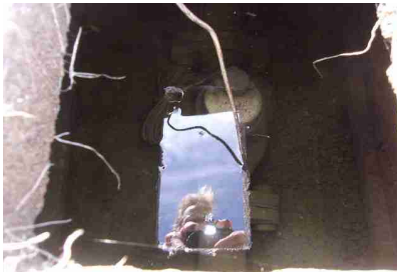
Valve appears original and was not tested, older valves are prone to failure and installing a new valve would be a prudent upgrade

The main shutoff valve is buried in the dirt. Recommend dirt be cleared to allow for full valve function, and to prevent corrosion..

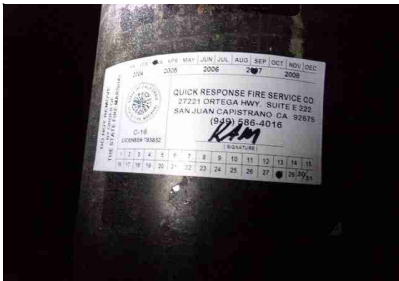
The fire sprinkler certification tag on the fire sprinkler system is not up to date. Recommend evaluation by a licensed C16 Fire Protection Contractor. (Tag is dated March 2007)

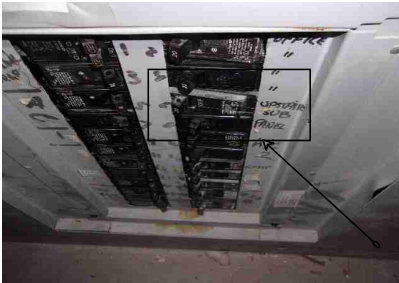
There is a loose breaker noted in the main electric panel. Recommend evaluation by a Licensed C10 Electrical Contractor.

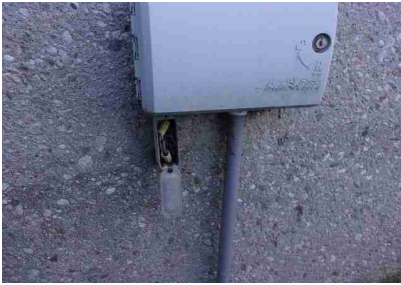
There is an open electric junction box below the sprinkler controller at the front of the building. Recommend evaluation by a Licensed C10 Electrical Contractor.

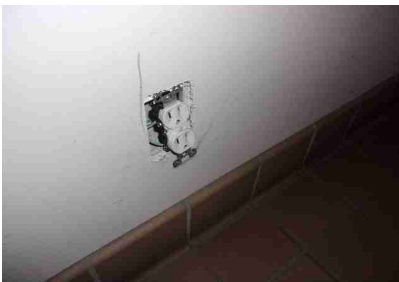
There is a loose uncovered outlet in the lower hallway that should be properly serviced/secured.

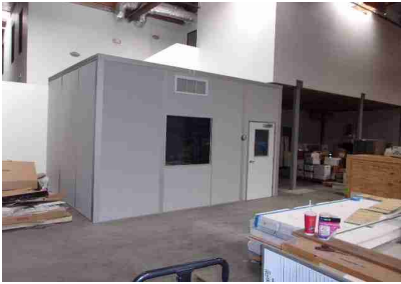
Portable office noted in warehouse - *Continued*

There is an added portable free standing clean room office in the warehouse. The portable added office does not have Fire Sprinklers or Central Air/Heat. Buyer is advised to inquire with seller regarding any code variances that were obtained for this office and as to whether or not it transfers with the sale. Offices are typically required to have fire sprinklers and adequate heat included to meet jurisdictional requirements

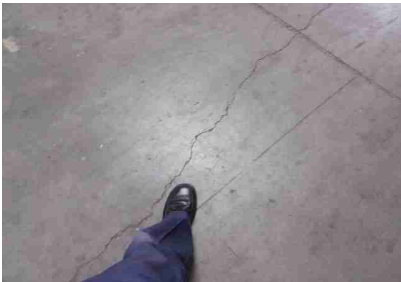
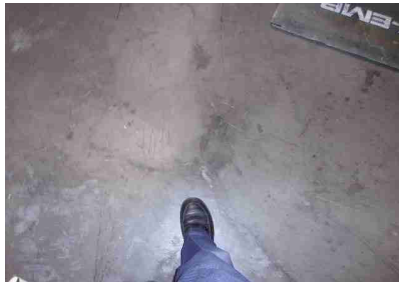
There are typical concrete flooring cracks visible within the Warehouse. These do not appear structural in nature, but we routinely recommend that they be sealed regularly

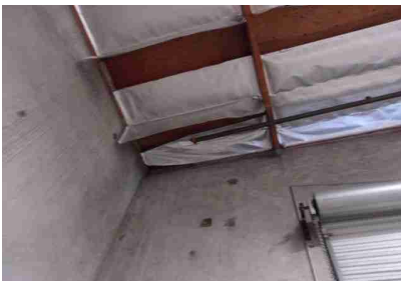
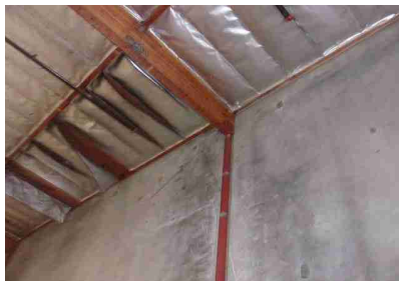
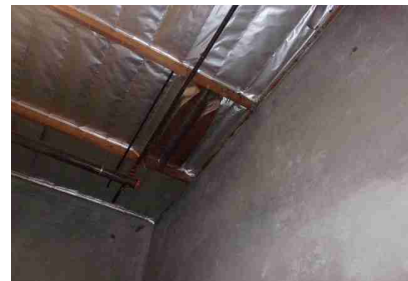
Some of the ceiling foil insulation is detached.. Recommend this material be properly replaced, or attached..

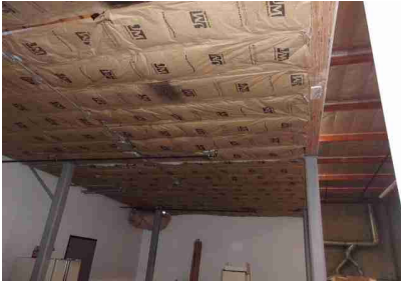
The paper on the insulation below the added office is exposed. This paper is flammable and acts as a condensate barrier which should be installed facing the occupied area. Insulation has been installed upside down. Recommend insulation be reversed and a batting or ceiling be installed.

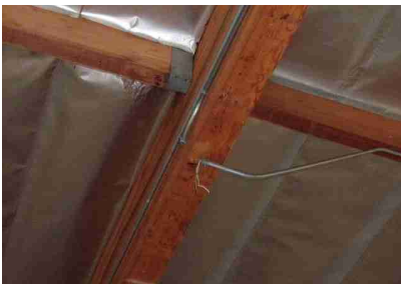
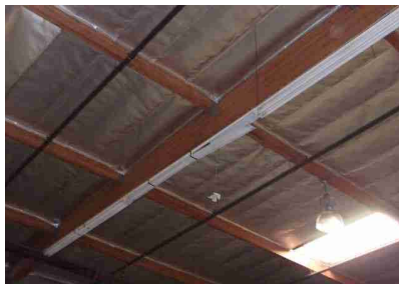
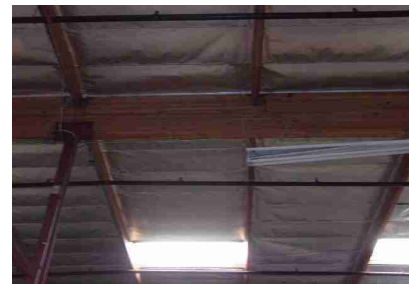
There are a number of broken fluorescent fixtures in the warehouse and an open wire connection above the west side stairway.. Proper repairs are needed. Recommend evaluation by a Licensed C10 Electrical Contractor

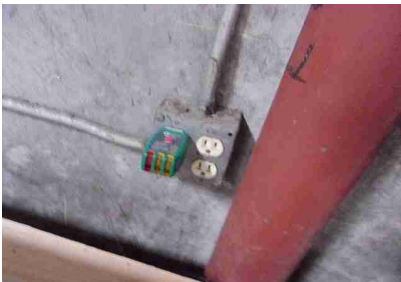
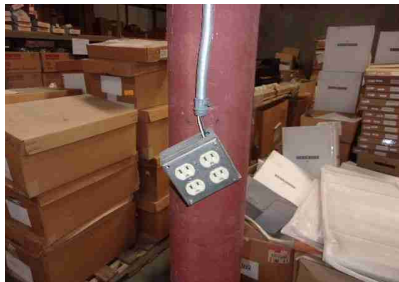
Dead outlets noted on the west wall and there is a detached conduit on the center pole outlet. Recommend evaluation by a Licensed C10 Electrical Contractor

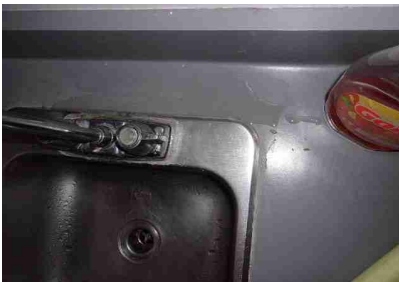
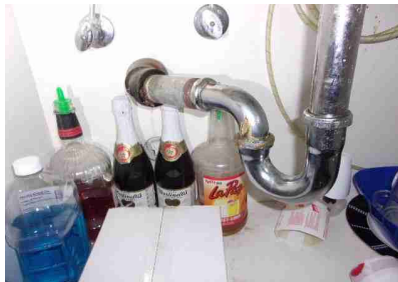
The lunch room faucet leaks around the stem while in use, which is indicative of a defective seal, and should be repaired or replaced. Recommend evaluation by a Licensed C36 Plumbing Contractor.
