CONFIDENTIAL INSPECTION REPORT

123 Your Street, Anywhere USA,

6/17/2006 10:00 am to 12:30 pm

SUMMARY REPORT

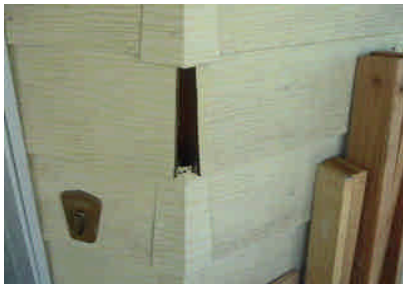
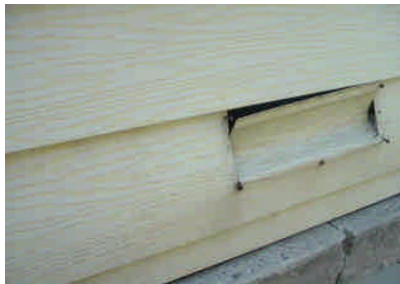
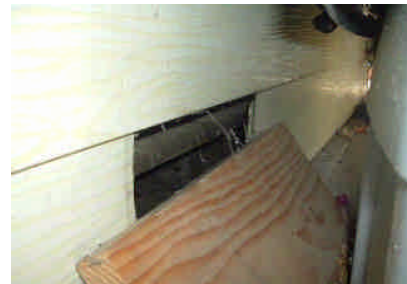
The exterior wall finish is in acceptable condition, but there is a missing corner piece noted that should be replaced, and some openings that should be covered or have vent screens attached to prevent animals from getting under the unit..

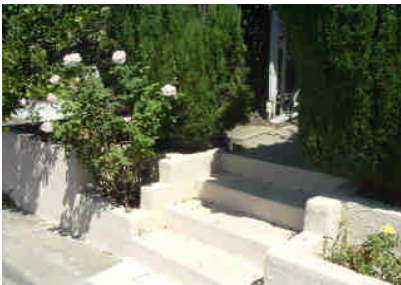
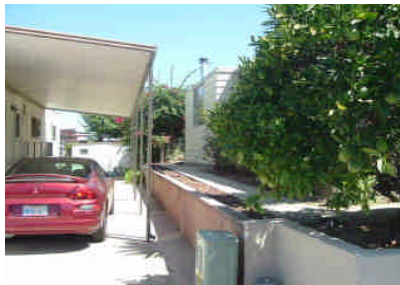
There is no grippable handrail on the front stairway, or at the raised wall on the left side of the lot. We routinely recommend grippable handrails at all stairways, and safety guardrails at all walkway drop-offs.

The front porch handrail is loose. Maintenance recommended.

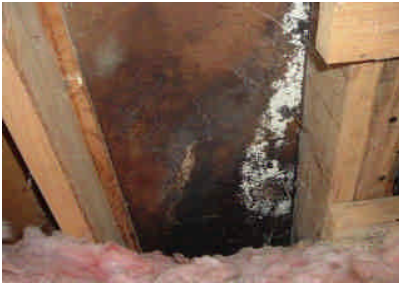
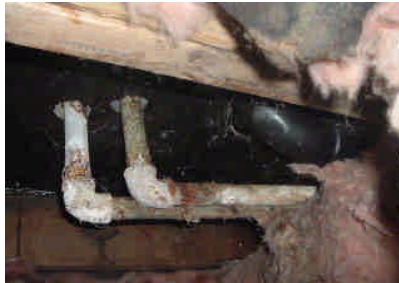
There is an active leak under the master bath/water heater area, and the sub floor is wet with dark staining noted.. I was not able to determine the source of leakage. Recommend evaluation by a Licensed C36 Plumbing Contractor who is familiar with leakage. We also recommend evaluation by a qualified Water Restoration Contractor who is familiar with manufactured homes and the problems associated with moisture contamination. (See Moisture Concern notations near end of report)

The area under the master bath is wet, and the insulation pulled down at this area. You may want to have repaired or re-batted to provide complete insulation after further work has been completed.. (See plumbing notation)

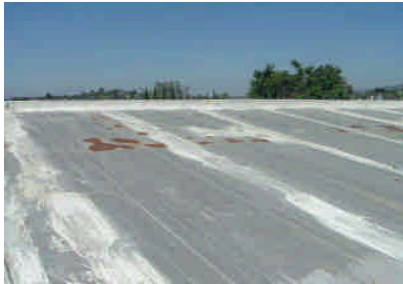
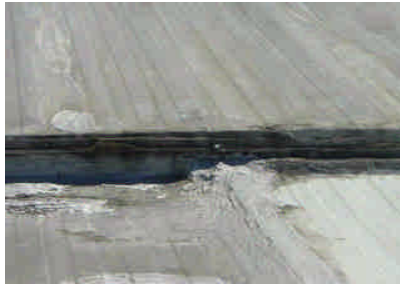
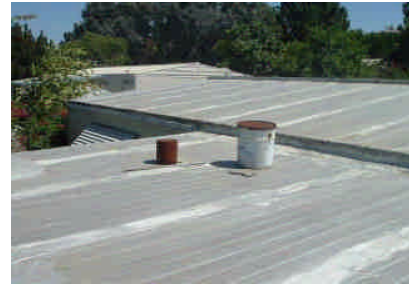
The roof has been repaired with mastic which implies that it has leaked at some point which is evidenced by staining on some ceiling panels, and there are some rusty areas that need to be sealed. (There is a can of sealant on the roof) You should ask the sellers about any past leakage, and have it evaluated by a roofing contractor to have it water-tested and sealed.

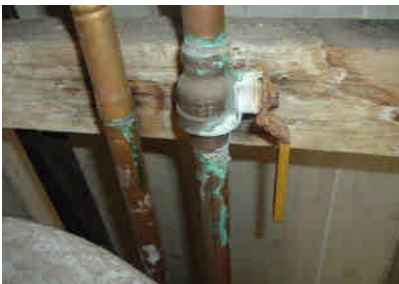
Corrosion noted on the water heater fittings or supply valve indicate past leakage or current seepage that evaporates before it drips.. Recommend evaluation by a Licensed C36 Plumbing Contractor.

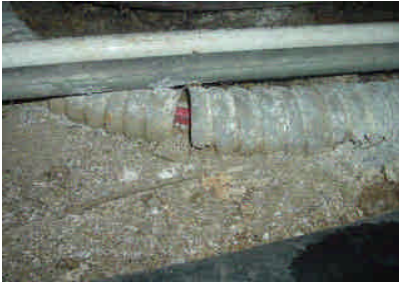
There is an older style flexible metal conduit connector from the main panel to the coach sub panel which is buried or laying directly in the dirt and is damaged. (Wires are showing) Recommend evaluation by a Licensed C10 Electrical contractor.

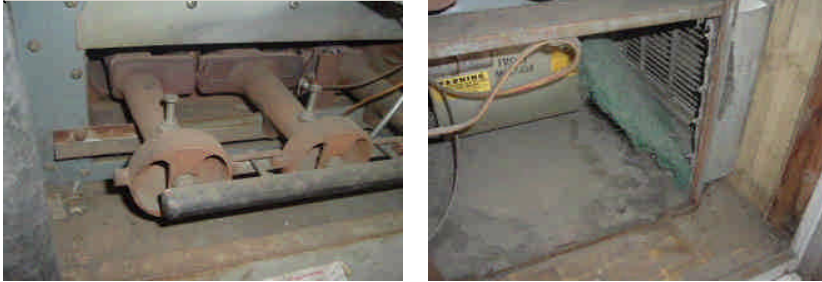
There is rust and dirt in the interior of the gas furnace. We routinely recommend professional evaluation by a Licensed HVAC Contractor when we observe this type of rust to ensure the rust has not damaged any interior components or the heat exchanger..

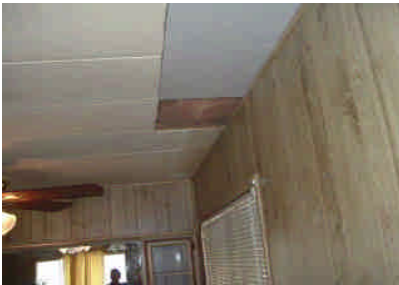
There are active ceiling repairs on going in the living room. Recommend consultation with seller regarding the reason for these repairs as they may be roof/moisture related..

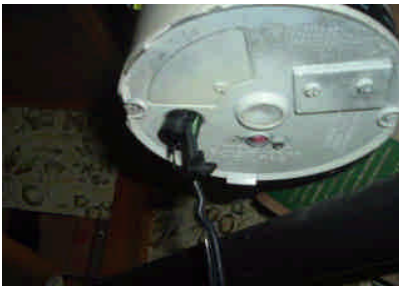
The electrical connection to the garbage disposal is substandard. Exposed wire connections noted.

Recommend evaluation by a Licensed C10 Electrical Contractor.

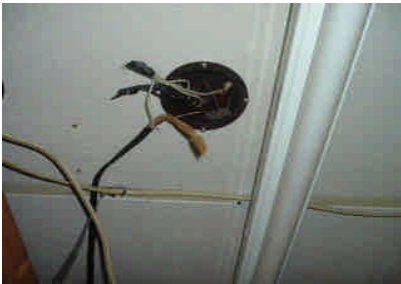
There is an open electrical junction box and exposed connections at the light fixture Recommend evaluation by a Licensed Electrician.

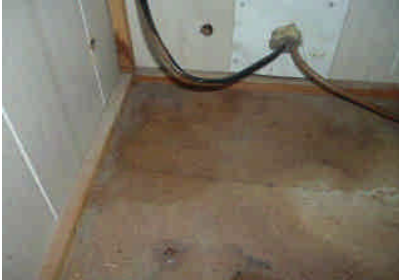
The floor of the sink cabinet is functional but moisture stained, this staining may be related to the leakage under the coach at this area. (See Moisture Concerns near end of report)
