CONFIDENTIAL INSPECTION REPORT

1234 Any Street, Your Town, CA

SUMMARY REPORT

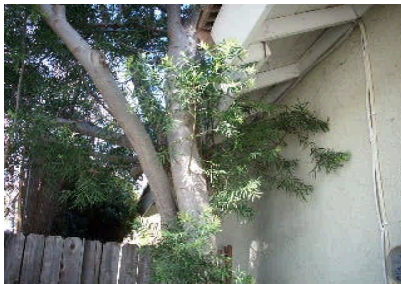
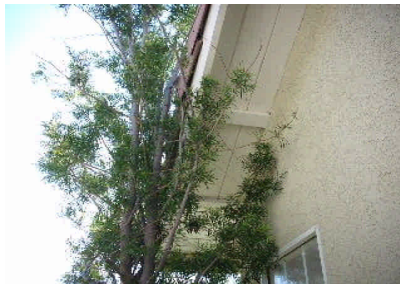
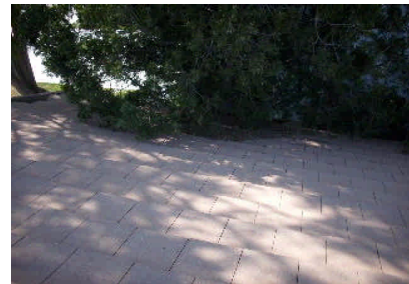
Shrubby ,vines, lawns, trees, tree limbs, and other landscape materials and components should be kept well clear of the structure to prevent water intrusion, encroachment on the foundation, and roof debris. Plants on the structure can also facilitate insect and/or rodent access to the building as well as deterioration of the weep screed. Vegetation may have prevented the full inspection of some exterior walls and foundation stem walls

We do not specifically evaluate landscaping, but we noted that the rear yard has been neglected. You will need to budget for landscaping and/or landscape maintenance..

There is a tree or trees growing close to the house and/or under the eaves. Recommend that you monitor this condition closely as they could eventually damage the structure. It would be prudent to have the trees evaluated by an arborist, we routinely recommend removal of trees near the structure/foundation.

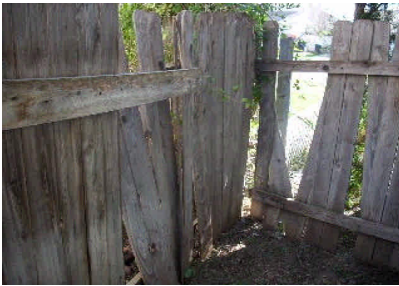
Sections of the wood fencing is leaning and/or damaged. Repairs are needed.

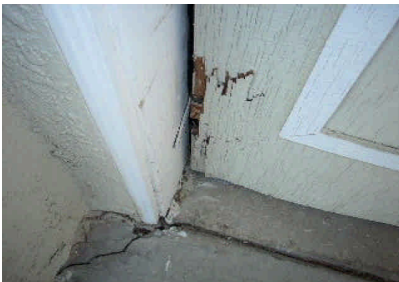
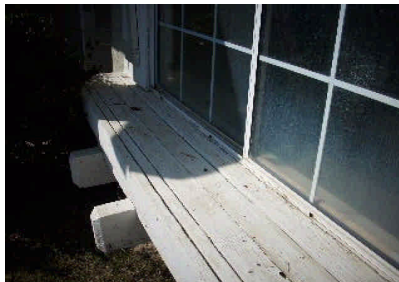
There is some wood wear, or deterioration noted on some window/door trim pieces, the garage doors, and the front plant shelf,. We are not qualified to comment on wood damage or insect concerns.. Refer to required pest report for further information including required actions or repairs.. In any case, maintenance is needed.

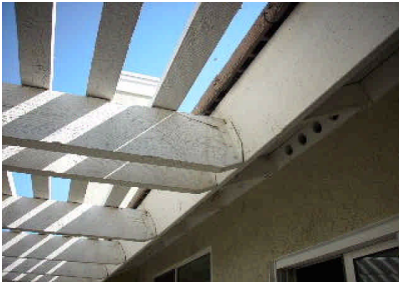
The patio cover is attached directly to the eave fascia board. This is not a normal attachment technique, as the eave fascia is a cosmetic feature, not a structural component. we routinely recommend confirming permits were pulled and signed off, or an evaluation by a qualified contractor who may suggest posts, or bracing brackets be installed.

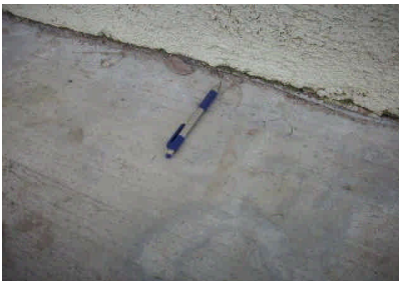
Inadequate weep screed clearance noted at rear decking. The weep screed is the metal strip with openings at the base of the exterior wall; it is designed to facilitate drainage from the wall cavity (weep) as well as a guide for the application of the stucco coat (screed). Proper installation requires a minimum clearance of 4 inches above soil or landscape material, and 2 inches above a solid deck. This clearance is to prevent clogging the holes with dirt and/or rust and deterioration of the screed, which could lead to moisture intrusion. Often times, landscape contractors fail to provide for the proper clearance when they grade and pour the deck up against the structure. If the deck has been poured to close to the weep screed, you need to be sure that dirt does not accumulate under the screed and plug the weep holes. If the concrete has been poured over the weep screed there is a chance that moisture will accumulate in the wall and cause damage/deterioration or other water intrusion problems, especially north facing walls. In such cases we routinely recommend evaluation by a qualified drainage or landscape contractor to suggest possible repair or drainage remedies.

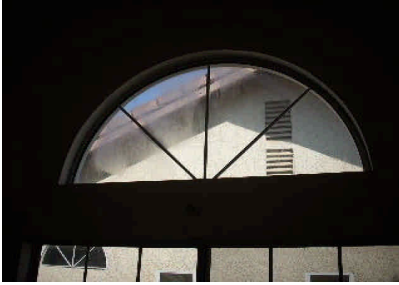
There are window panes with broken hermetic seals - *Continued*

There are window panes with broken hermetic seals. High arched windows.. We routinely recommend all windows be checked by a C17 window glazing contractor for remedy and to ensure this condition is not common to other windows as it is not always readily visible.

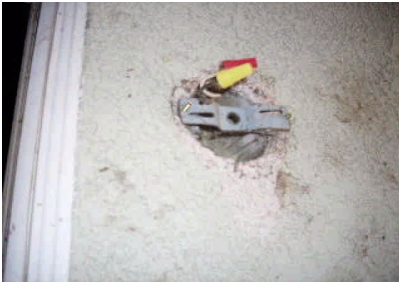
The side garage exterior light fixture is missing.. Fixtures will need to be replaced.

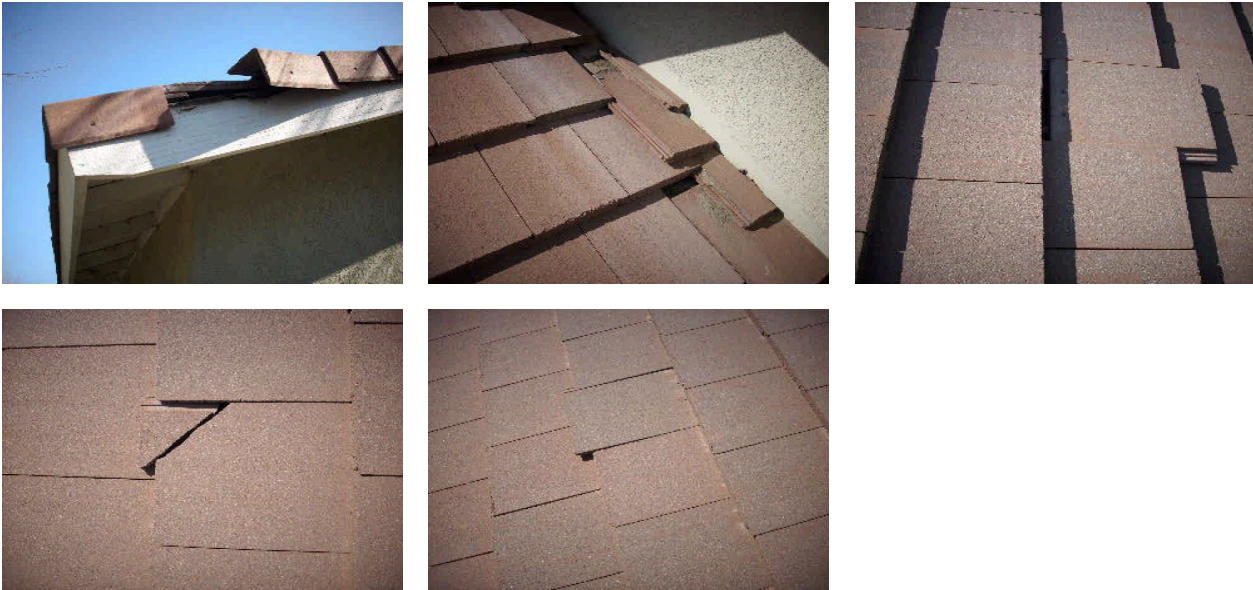
Cracked slipped broken and detached roof tiles noted - Continued

There are a number of cracked tiles, broken tiles, slipped tiles, and detached tiles at various locations. Recommend evaluation by a Licensed C39 Roofing Contractor.

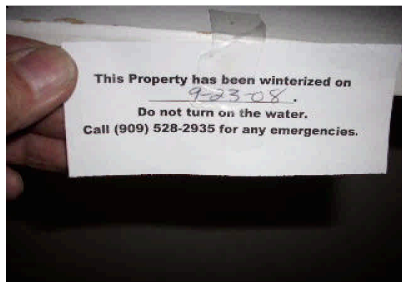
The plumbing system was winterized.. This is a protective measure typically performed on structures that are left empty in "Freezing Temperatures".. This process entails shutting off the main valve, and closing all of the angle stop valves under the sinks, and behind toilets.. Operating angle stop valves that have not been used for many years can contribute to seepage and or distortion of valve seals that can lead to latent seepage that gets worse over time.. We recommend that you have the Plumbing Contractor who winterized the system back out to re-check and certify that there are no additional leaks when the system is restored..

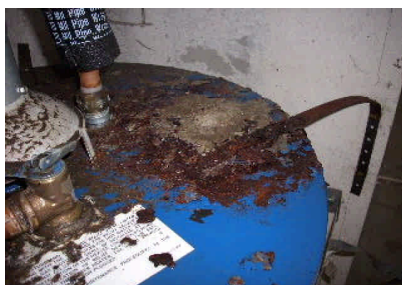
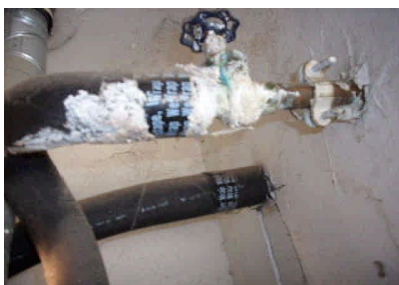
There is rust around the combustion box area, and the top of the unit is rusty, and swollen. This type of rust and swelling indicates the unit is at, or near the end of it's serviceable life. Recommend evaluation by a Licensed Plumber..

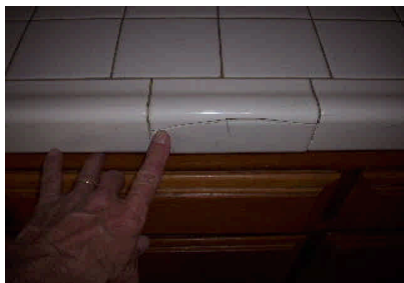
The counter top has typical cosmetic damage, which you should view for yourself.

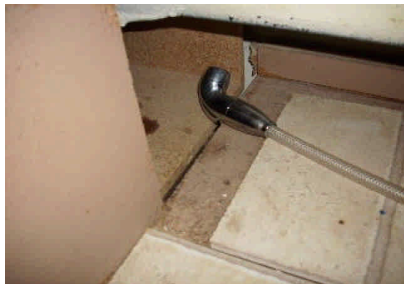
Spray wand under sink - Continued

The spray wand is laying under the sink. We routinely recommend that these be disconnected to prevent accidental leakage.

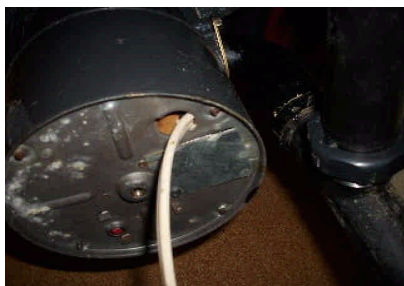
The garbage disposal needs a new rubber sink throat insert..
Components and Conditions Needing Service
There is no clamp on the garbage disposal wire. Clamping is recommended as a safety feature..

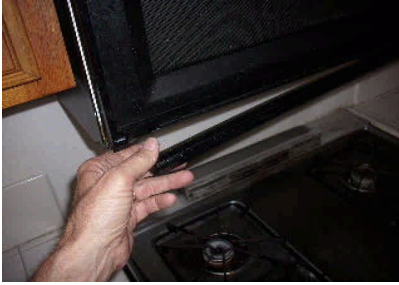
Components of the built-in microwave are broken or missing - *Continued*

Built-in Microwave
Components and Conditions Needing Service
Components of the built-in microwave are broken or missing, and should be repaired or replaced.

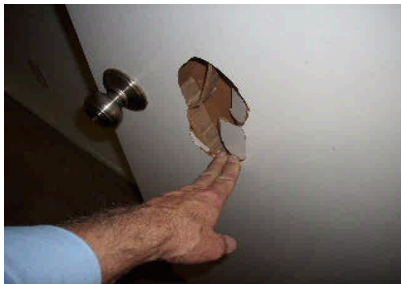
The doors are functional, but the first guest bedroom door is damaged and will need repair/replacement.

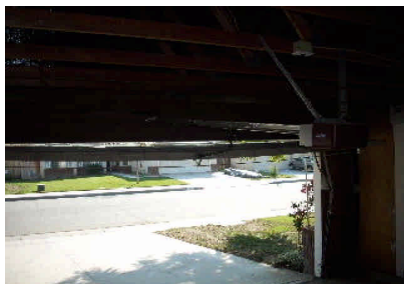
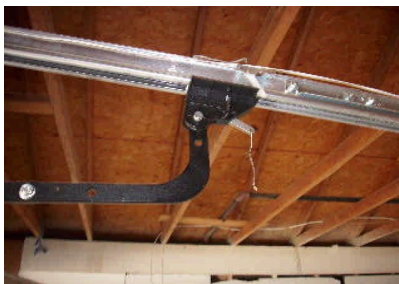
The large garage door is sagging. Recommend evaluation by a qualified overhead door contractor.
